MOUNT HIGBY RESERVOIR DAM  
CT. 00140

PHASE I INSPECTION REPORT  
NATIONAL DAM INSPECTION PROGRAM

FEBRUARY, 1979

Identification No: CT 00140  
Name of Dam: Mount Higby Reservoir Dam  
Town: Middletown  
County and State: Middlesex County, Connecticut  
Stream: Fall Brook  
Date of Inspection: 8 November 1978

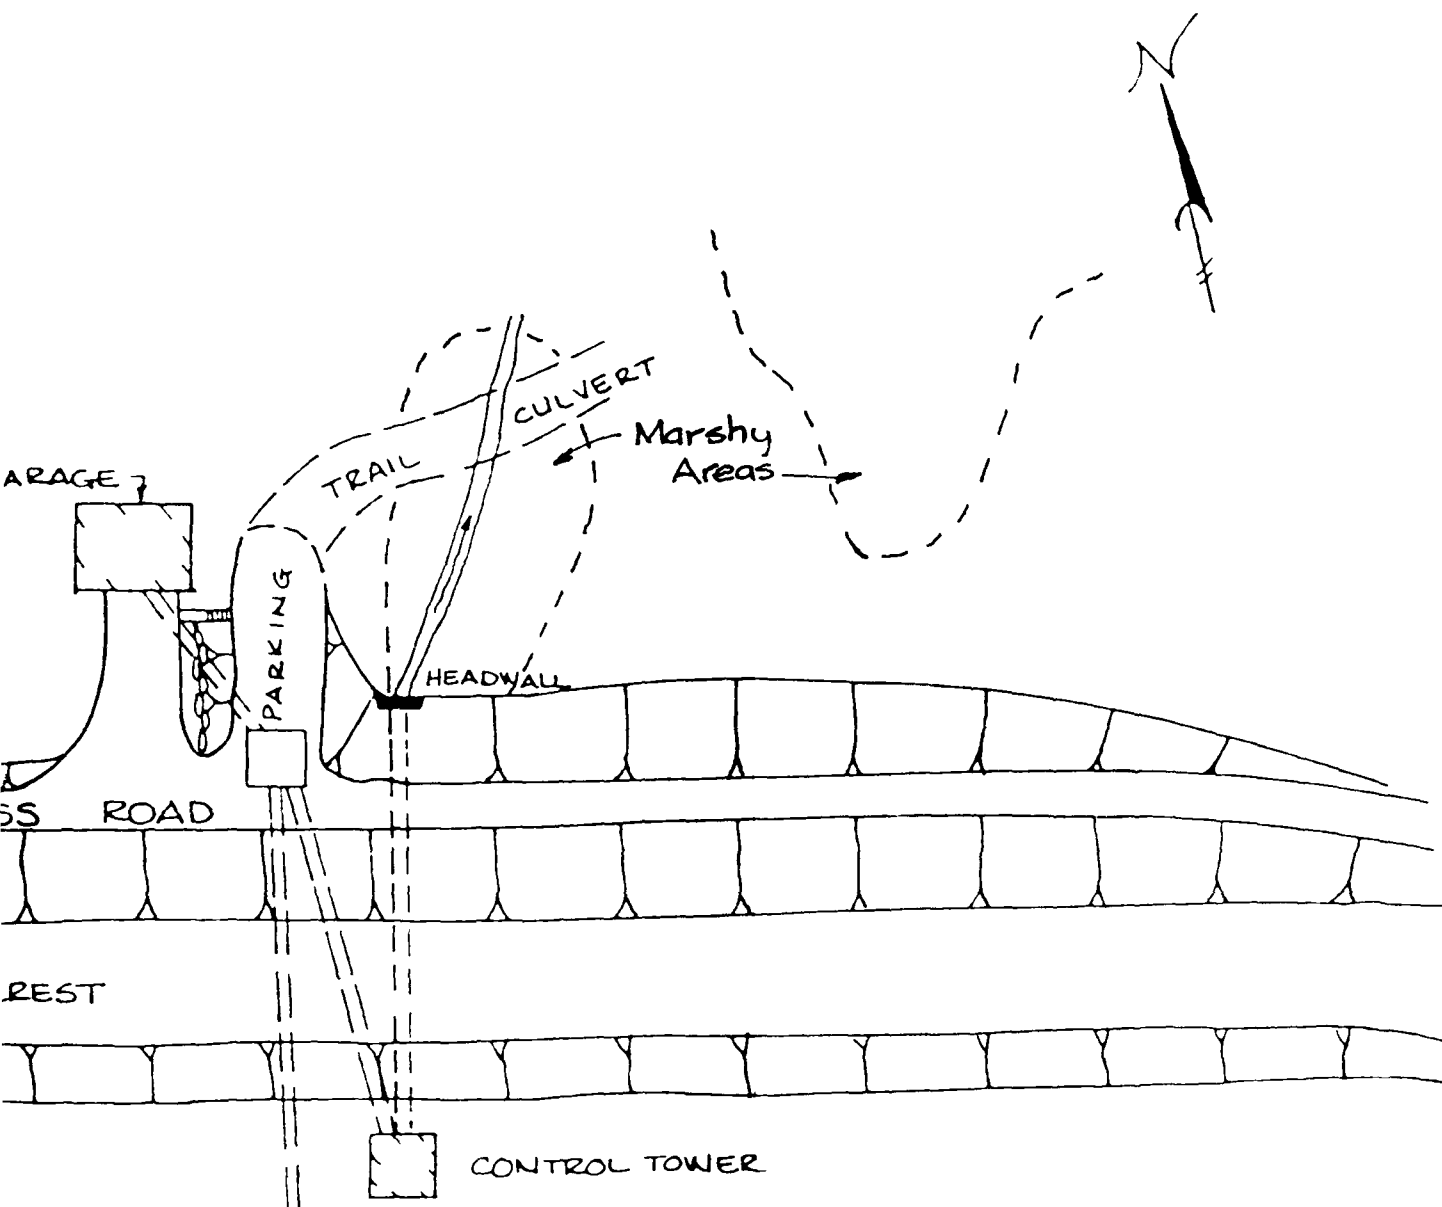
SKETCH PLAN & PROFILE  
FIGURE 1 - SHEET D-1

The left abutment appears to be founded on bedrock, as evidenced from rock outcrops along the spillway channel. The right abutment foundation material is not known. Sketch plans and profiles of the dam and appurtenant structures are shown on Figure 1, Sheet D-1, Appendix D.

No data on the design of the dam or appurtenances has been recovered and probably none exist. In the course of the inspection, measurements were taken and a sketch plan and profile layout of Mount Higby Reservoir Dam and appurtenances has been prepared. These sketches are shown on Figure 1 in Appendix D.
